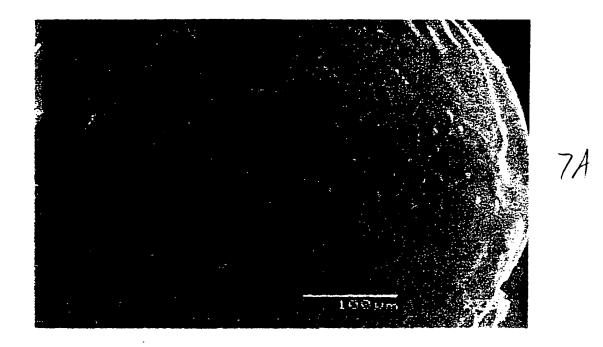
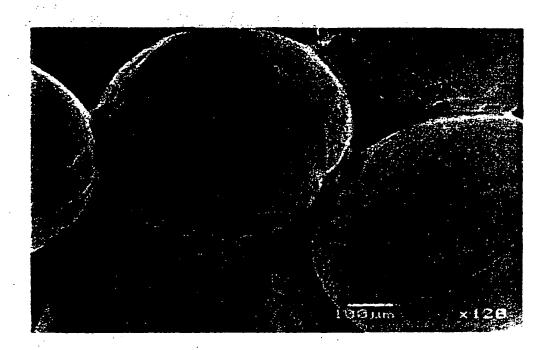
SEM micrographs of the Hayes CrCoMo sample after ASTM F746 corrosion test indicates intergranular corrosion attacks.

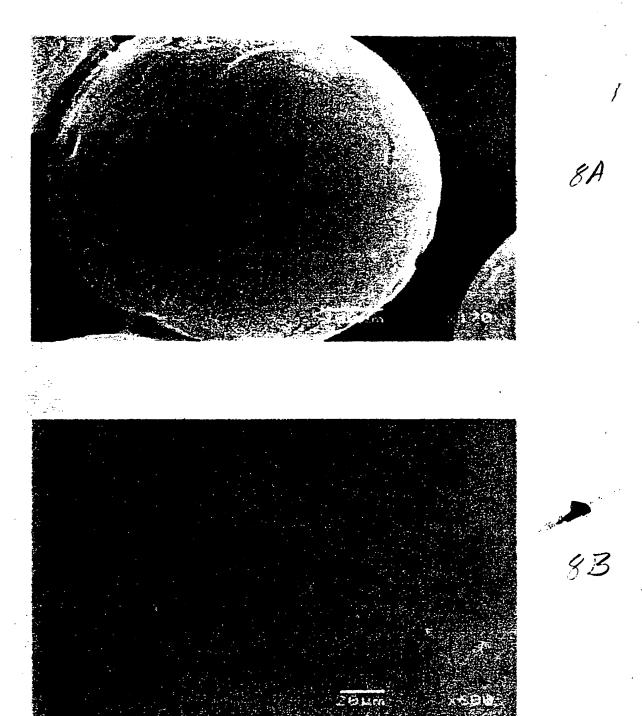
SEM micrographs of the Hayes CrCo sample prior to any corrosion test.
